APPENDIX N

2012 CONSUMER CONFIDENCE REPORT

WATER QUALITY REPORT 2012 &
WATER USE EFFICIENCY UPDATE

Skagit
PUD
PUBLIC UTILITY DISTRICT

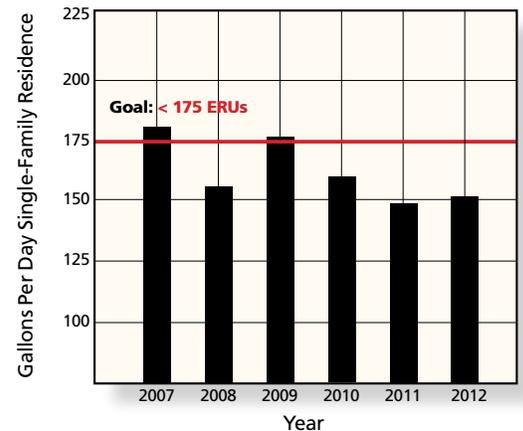
Equivalent Residential Units

demand (ADD). ADD is defined as the average quantity, over a one-year period, of daily water usage in the water system. In 2012, ADD for the Judy Reservoir system was 7.89 million gallons per day (mgd). Summer peak flows were 12.68 mgd. The trend of the last several years, which has featured cool conditions in the late spring and early summer transitioning to warm conditions in the late summer and early autumn, continued in 2012.

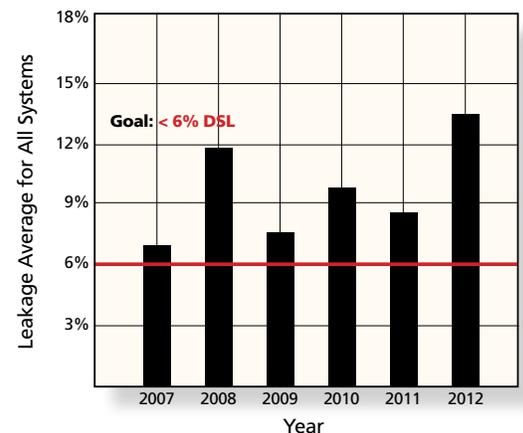
Distribution System Leakage

In 2012, the average water loss reported from distribution system leakage within Skagit PUD's main Judy Reservoir system was **13.5 percent**. One explanation for why this number increased in 2012 is due to a change in our data calculation process. In order to improve our measured

water production rate accuracy, Skagit PUD plans to replace older production meters located at Judy Reservoir's water treatment plant. The new meters will provide a more precise total of the actual water being produced and entering the distribution system.
